October 8, 2015

**Re: Maverick Mart, LLC,
Plaintiff
v.
North Star Mutual Insurance Company,
Defendant
United States District Court
Western District of Oklahoma
Case No. CIV-14-1165-F**

7421 South Pennsylvania Avenue
Oklahoma City, Oklahoma

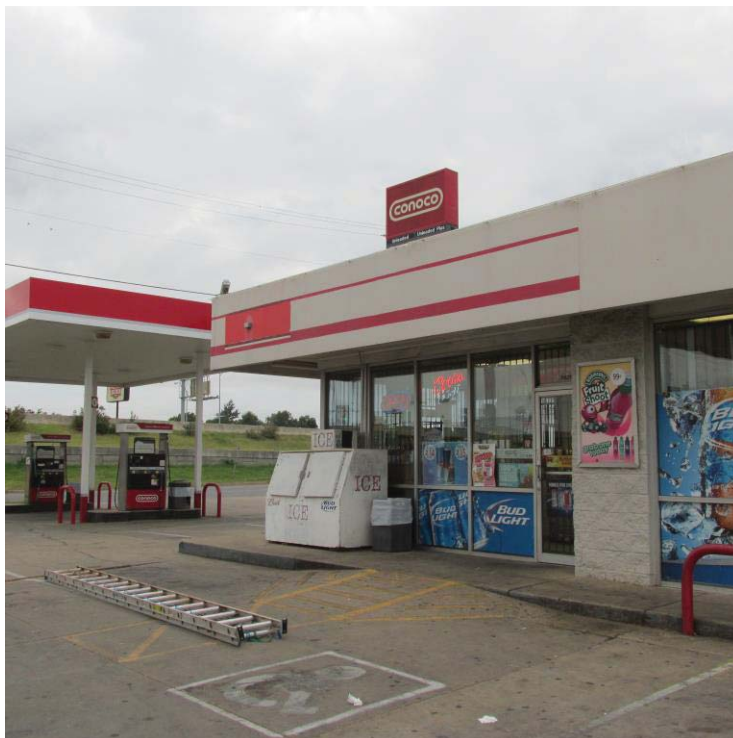
The Maverick Mart property, located at 7421 S. Pennsylvania Avenue, Oklahoma City, Oklahoma consists of four structures: a main building with an attached storage shed; two gas station canopies; and a car wash. The main building structure appears to be a steel framed masonry structure typical of gas station and convenience store construction. The exterior cladding of the structure is a combination of painted split face block masonry veneer with metal panel fascia. The roof covering of the main building utilizes a modified bitumen roof membrane. The main structure is deemed to face east for the purposes of this report.

1.1 The roof system and related roof top appurtenances of the property's main building suffered hail damage. There is evidence of impact damage and extensive loss of granulation resulting from impact. The following items were damaged and have yet to be repaired.

- Modified bitumen roof and underlying perlite insulation
- Associated roof jacks, pitch pans and parapet/cap flashings
- Cooling coils on three (3) roof top HVAC units
- Cooling fin combing on one (1) roof top HVAC unit

I noted no hail or other storm damage to the exterior wall surfaces of the main building. The paint on the CMU exterior walls was not compromised. The exterior metal fascia panels were not dented or otherwise affected by hail or storm activity.

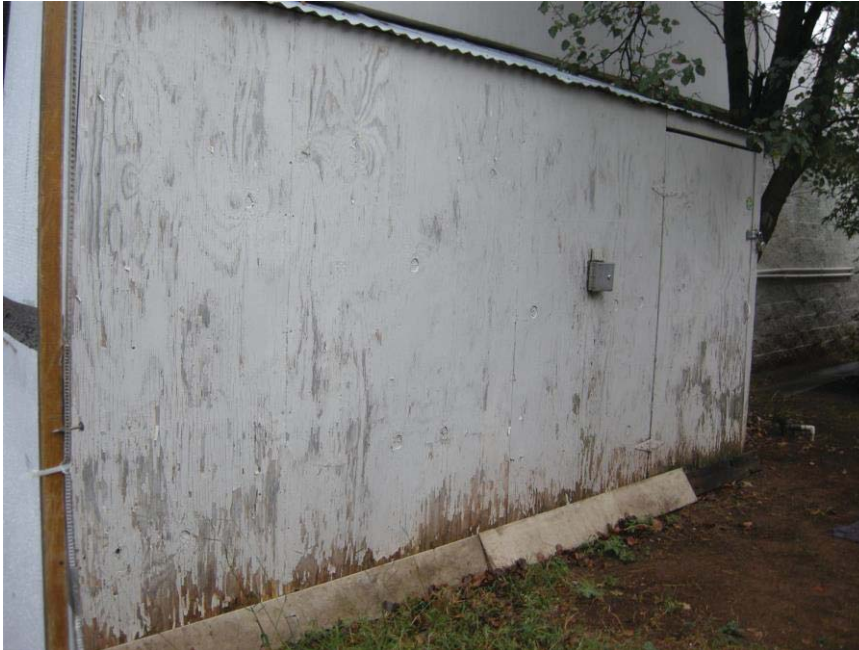
The main building of the subject property has an attached, "lean-to" storage shed at the rear. The shed has a corrugated metal roof and painted wood siding as an exterior cladding.

1.2. The lean-to storage shed attached to the west elevation of the main building revealed evidence of damages caused by hail. The following roof components and the exterior siding have been damaged, but not yet repaired:

- Replacement of the corrugated metal roof system
- Scrape, prep and repainting of the exterior wood siding

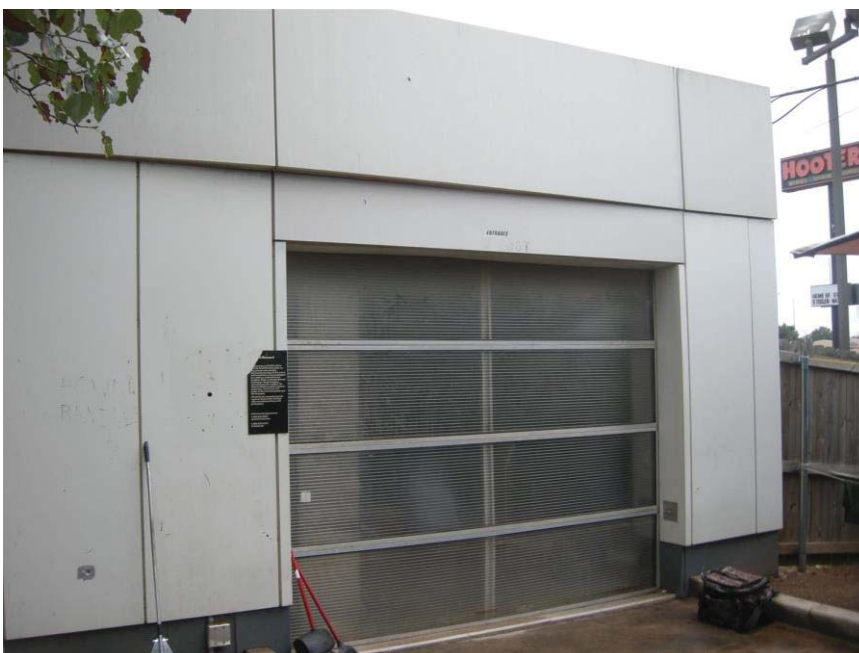
The car wash is a single level building clad with painted metal panels. The roof system is an EPDM (ethylene propylene diene monomer) roofing membrane.

1.3. The car wash building's EDPM roof membrane exhibited localized damage caused by mechanical impact, possibly from the dislodged fascia panels on the west elevation. This can be repaired and did not necessitate the replacement of the entire roof system.

- The roof membrane system was not damaged by hail. The roof system showed significant signs of wear and age deterioration that included open, unwelded seams and detached flashings.
- The exterior wall surfaces of the structure were not storm damaged and did not need re-painting. The extruded plastic exterior signage was not damaged.
- Approximately 22 LF of metal fascia panels were dislodged at the west elevation of the structure. These panels need to be replaced.
- Three (3) polycarbonate light lenses at the wall pack exterior lighting units were broken and needed replacement.
- The work estimated by North Star has not been performed.

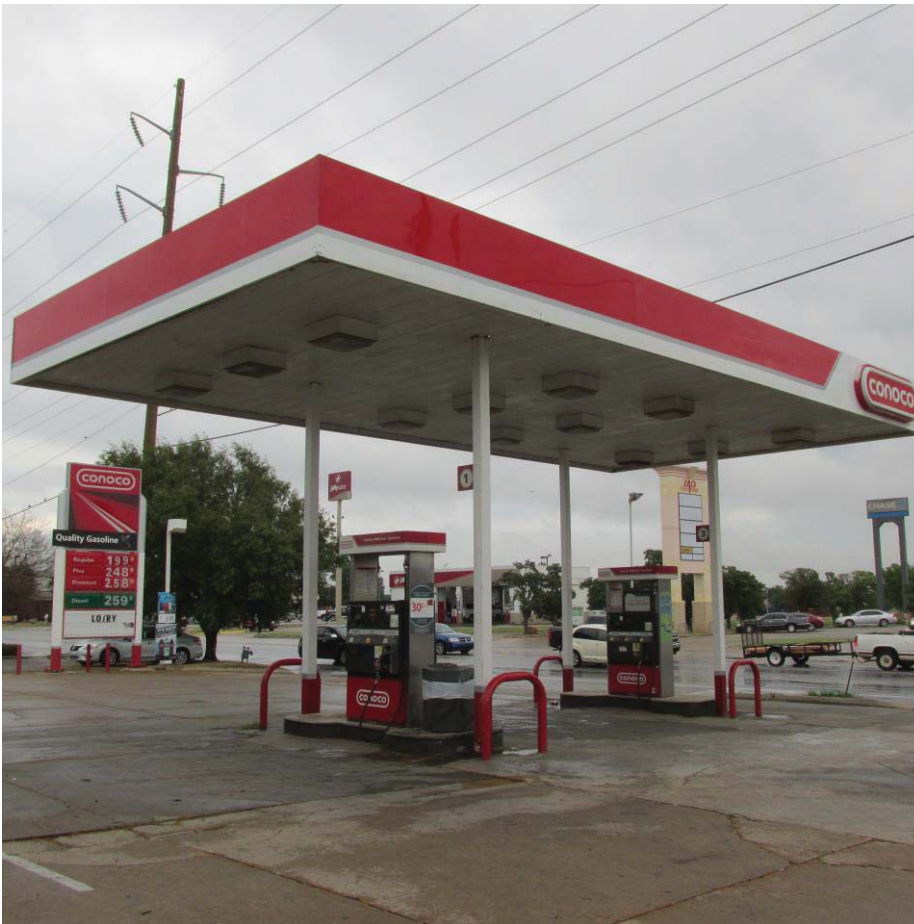
The fuel canopies were constructed with pre-engineering metal structural beams, purlins and metal roof decking. The four elevations were clad with a pre-manufactured, painted metal fascia panels.

1.4. The metal fascia panels at the north fuel canopy exhibited minor dents caused by hail at the portions of the west and south elevations, only. The north and east elevations showed no evidence of hail impact. The metal deck of the canopy, the canopy columns and the canopy signage were not damaged. The dented fascia panels, although estimated by North Star, have not been addressed.

1.5. The metal fascia panels at the north, east and south elevations of the south fuel canopy revealed some hail damages. These panels can be removed and replaced. The metal deck of the canopy, the canopy columns and the canopy signage were not damaged. While there was evidence of hail "splatter" at the metal deck, I was able to remove this oxidation to better expose the panel surface and reveal no damage.
